### Status of Fukushima Daiichi NPS November 2013

### Hideki Masui Safety Research Manager Tokyo Electric Power Company

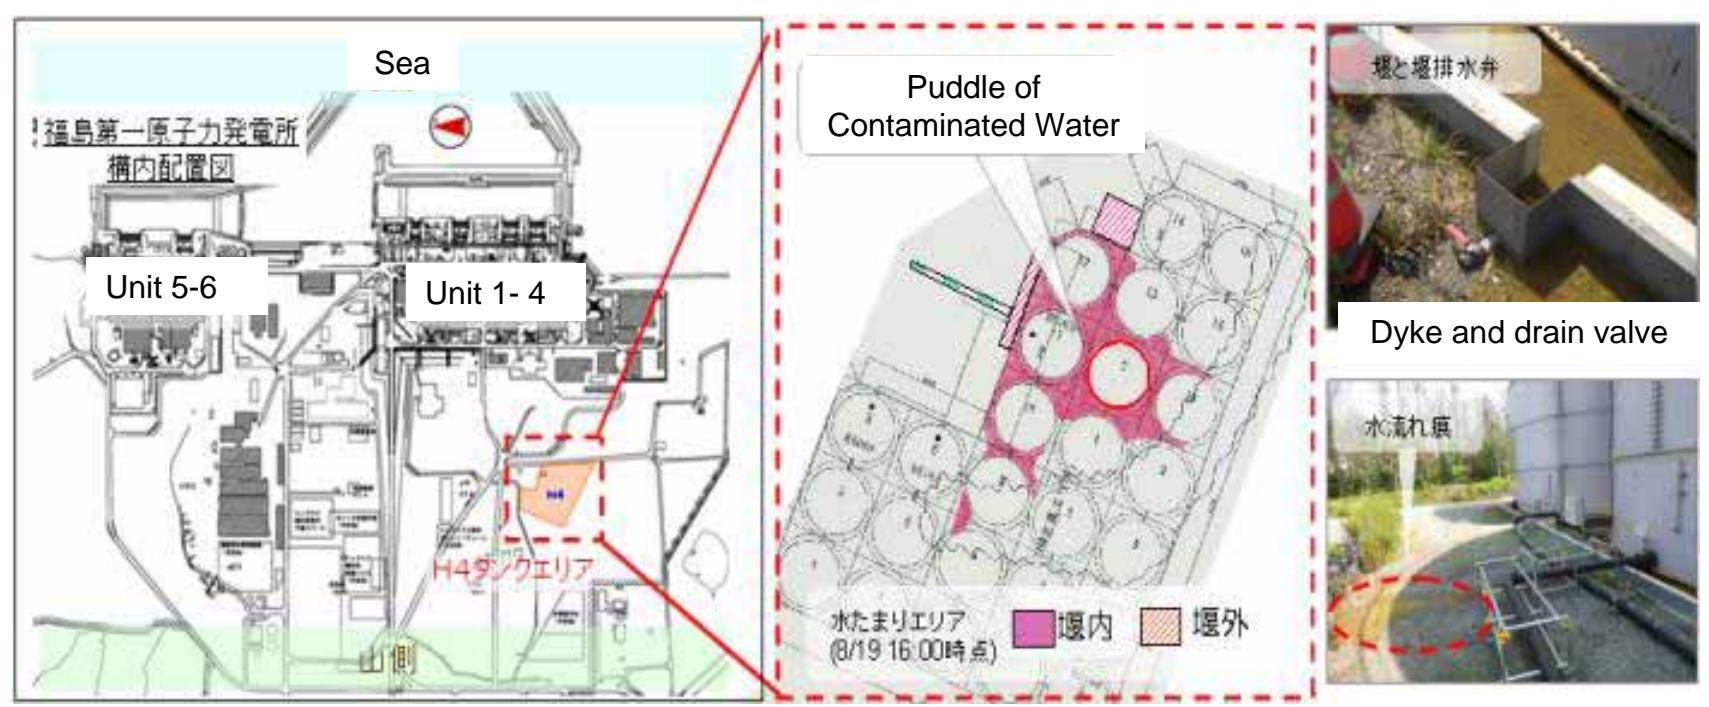
- On Aug.19, water puddle was found around storage tank. Tank level was found to be reduced by 3m (equivalent of 300m<sup>3</sup>).
- Since drainage value in the dyke was open, some portion of water was leaked outside dyke.
- •This event was rated to be INES level 3.

Trace of leakage

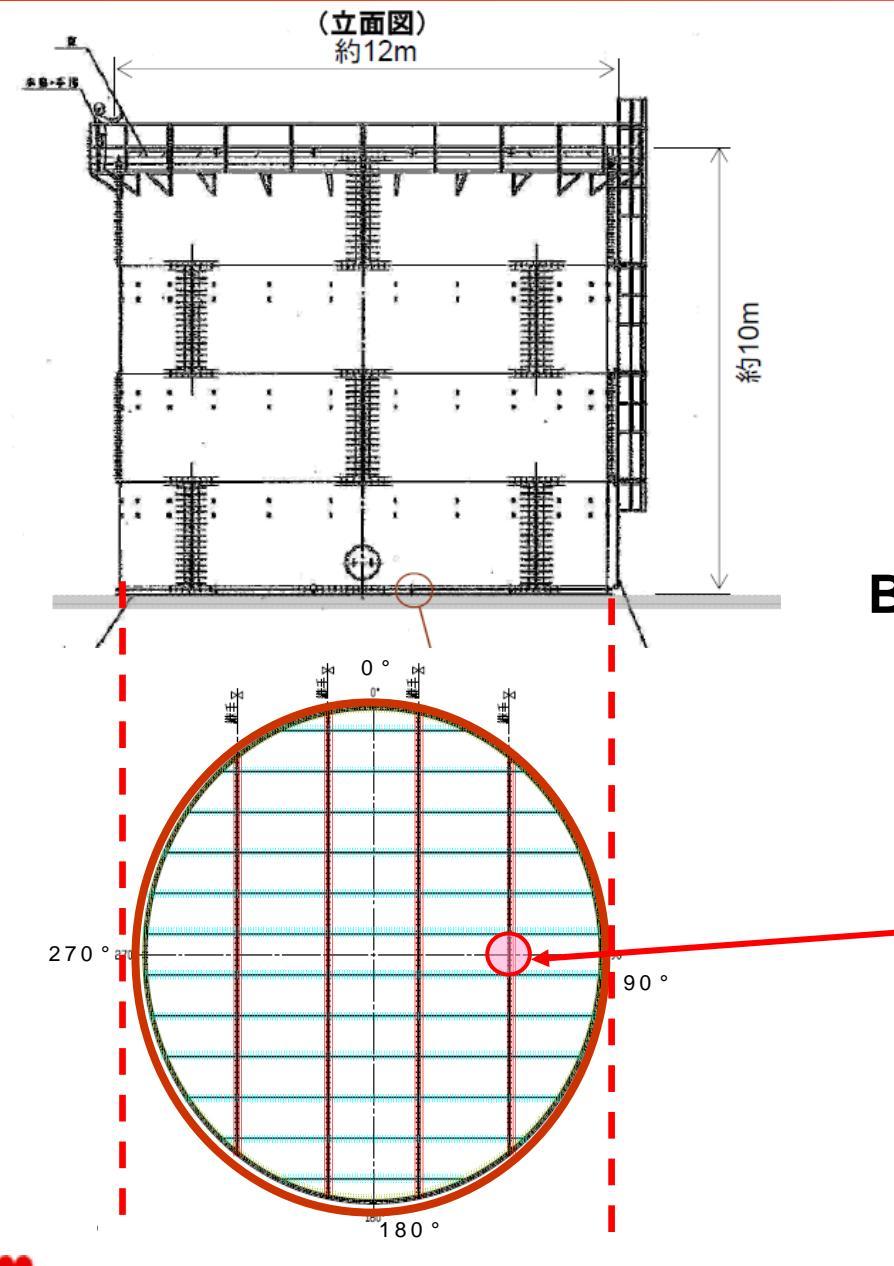
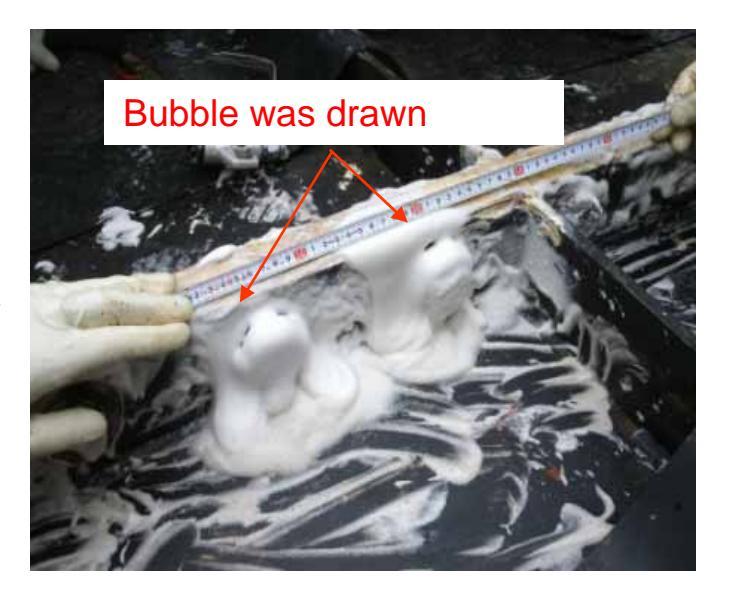
Tank has been disassembled and various tests have been conducted

Bubble test identified leakage point

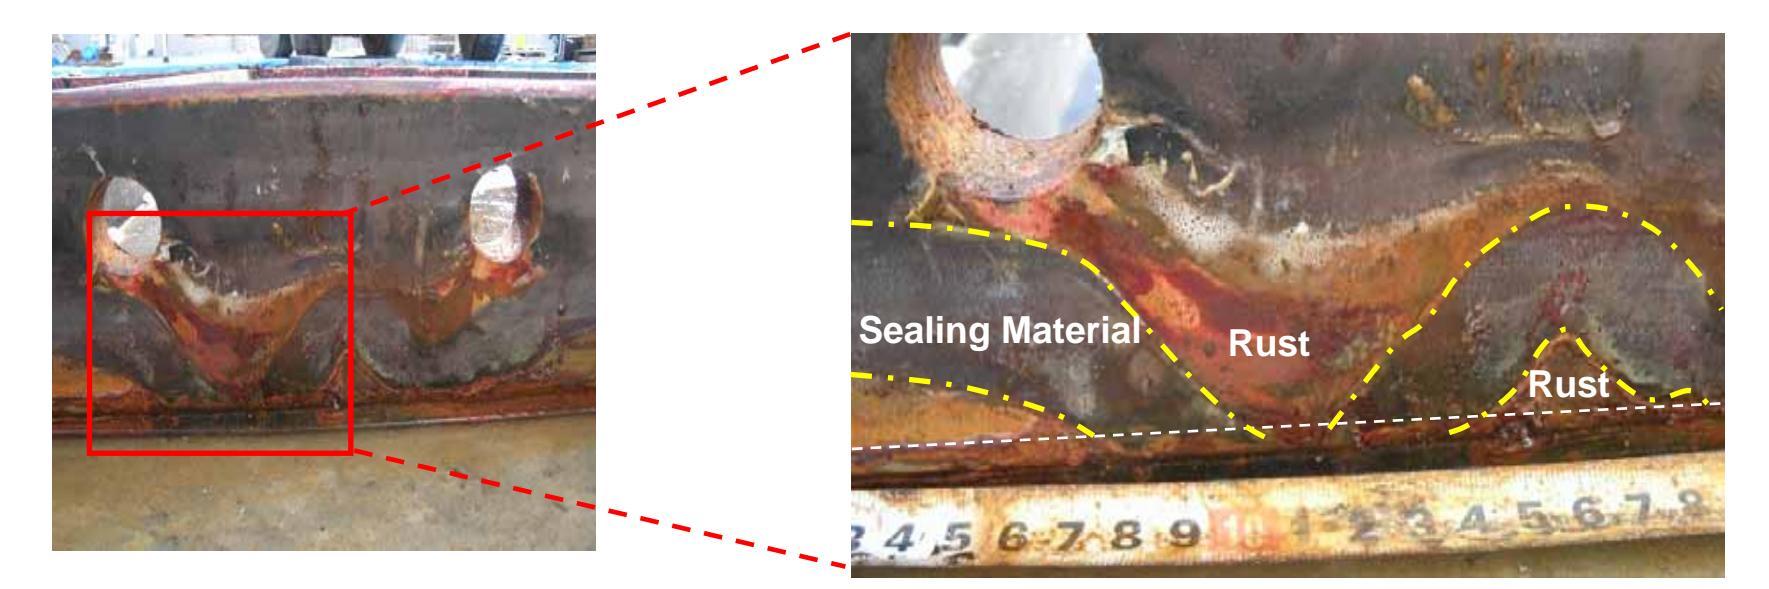
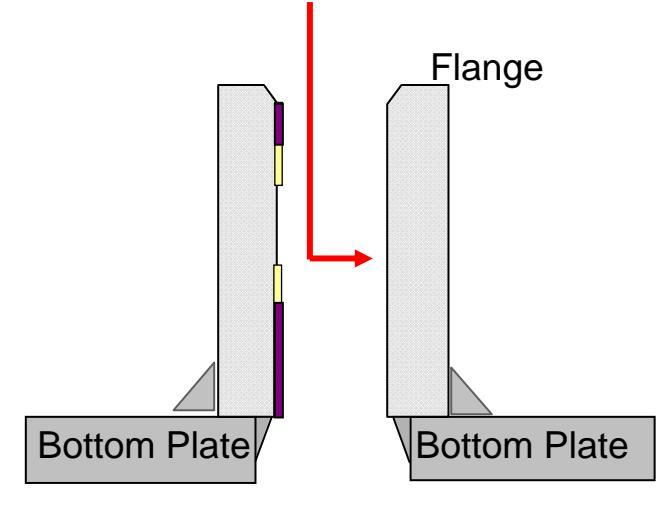
# Deformed sealing material caused leakage.

- 1. Collection of residual water. Recovery of contaminated soil. Inspection of all flange-type tank.
- 2. Enhanced patrol. (twice 4 times a day, 10 60 people)
- 3. Closure of drain valve
- 4. Enhanced monitoring along gutter
- 5. Water level measurement by thermograph

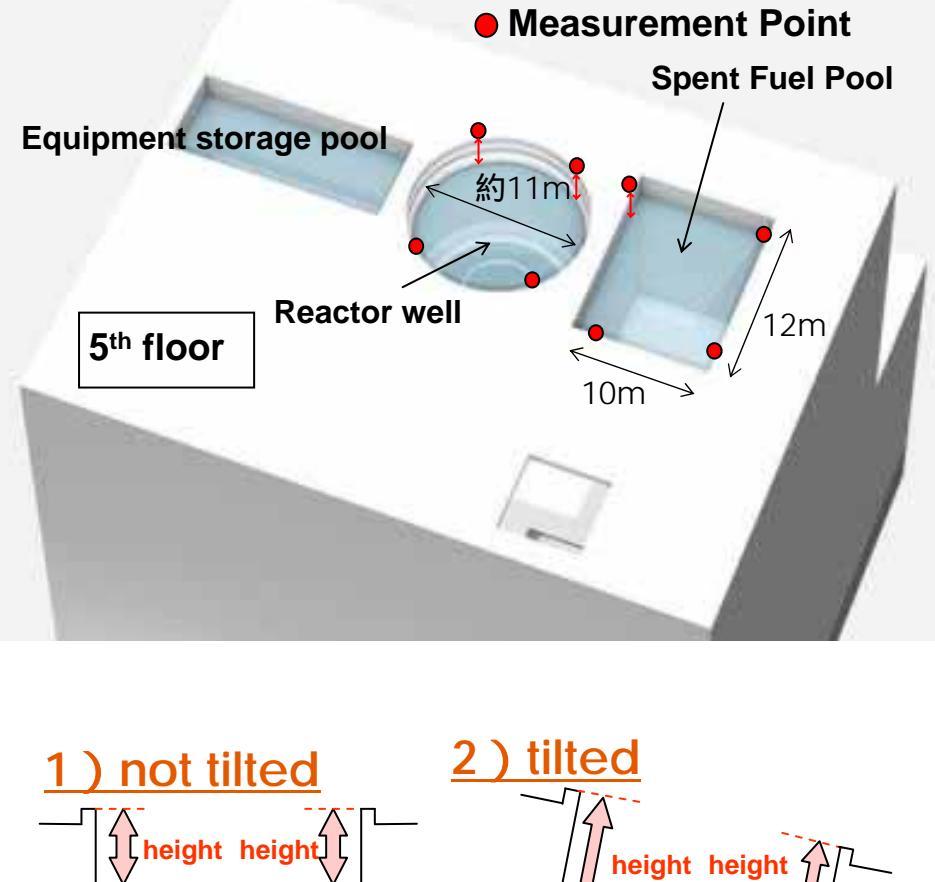
### Measurement result has confirmed SFP is not tilted

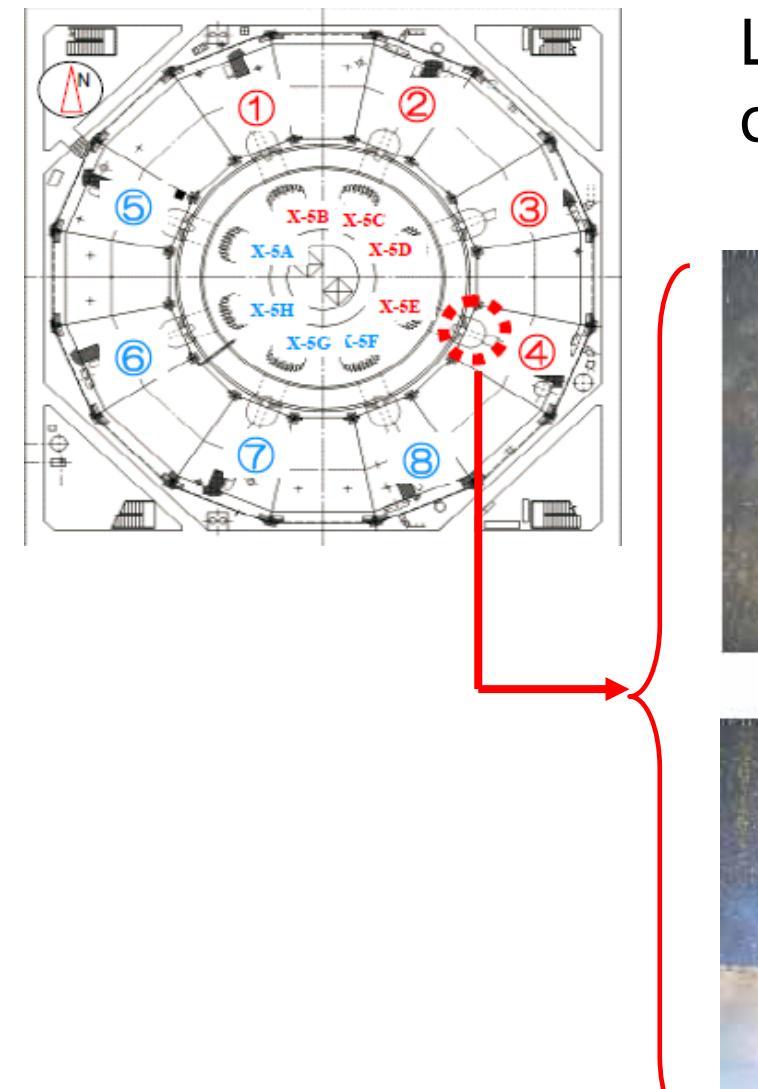
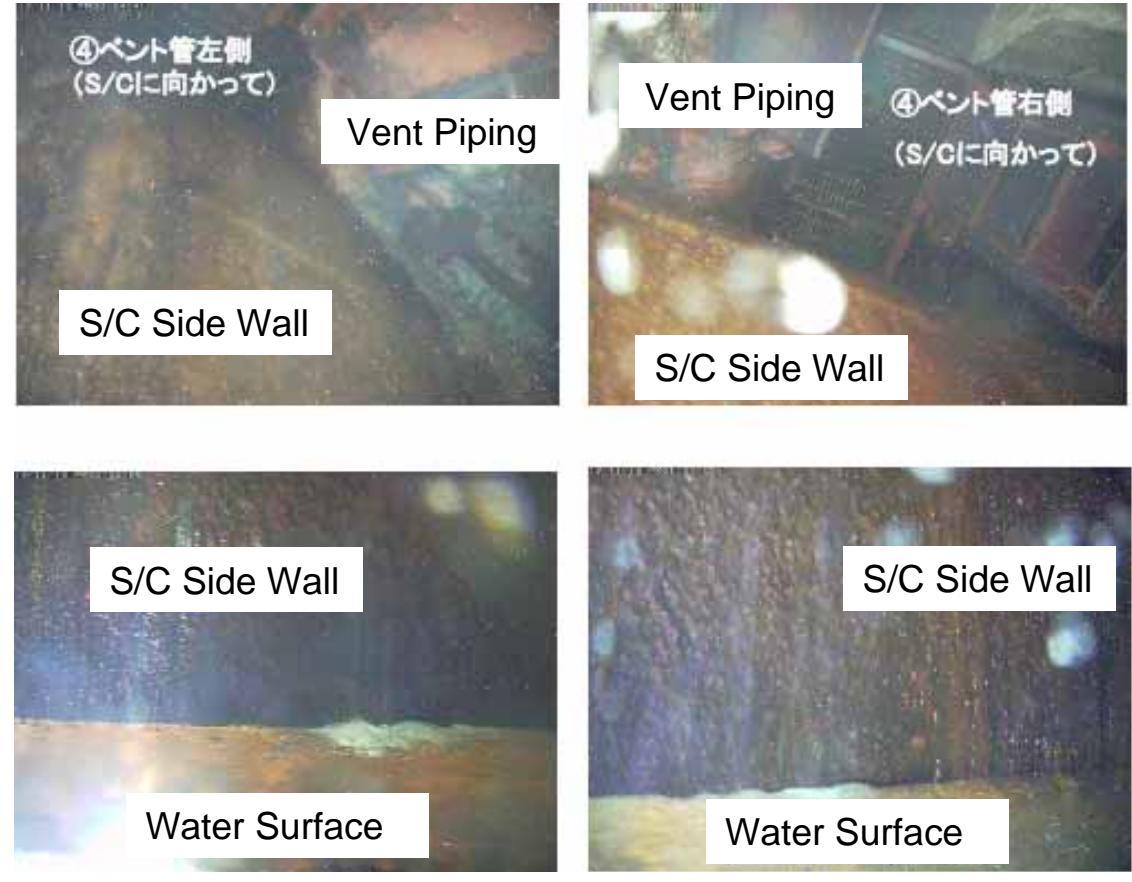
Leakage has been identified around one of 8 vent piping.

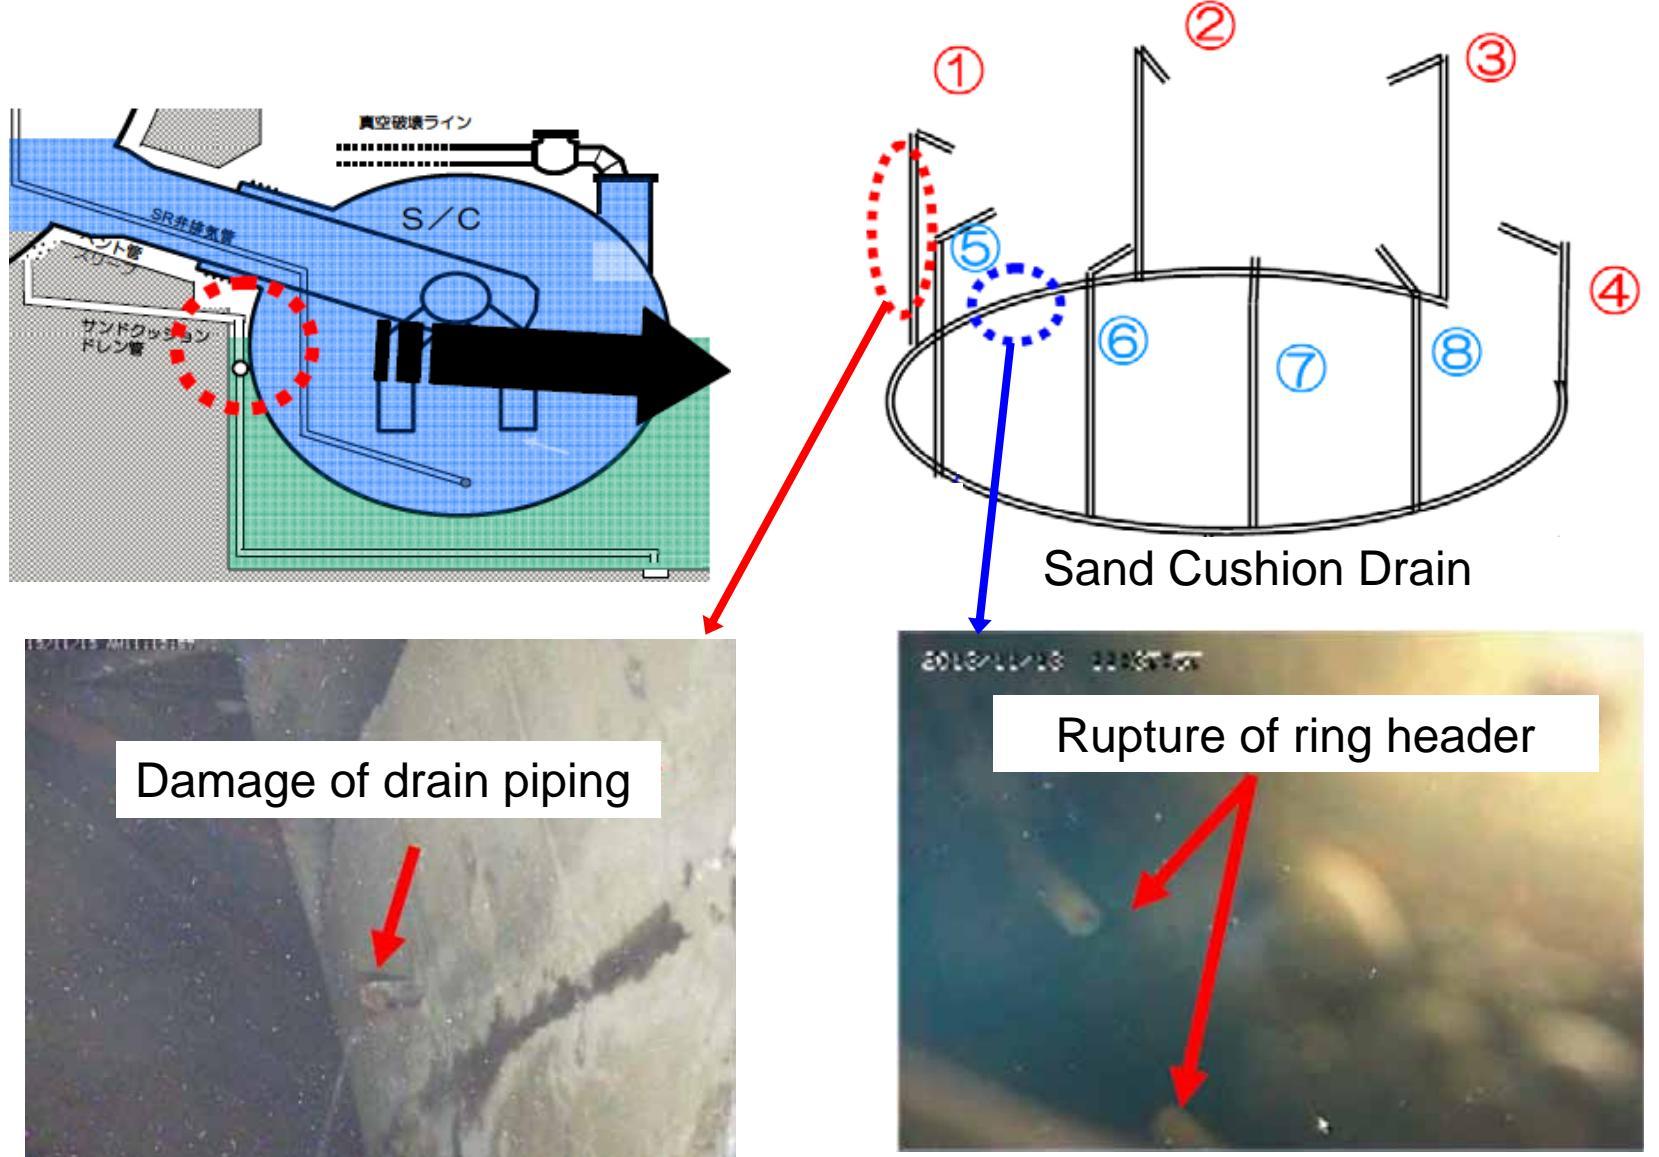
Damages were found at sand cushion drain (not PCV boundary)
