# Reactor core meltdown and radioactivity release during the Fukushima Daiichi accident

12/06/27 Ebisawa T

1. Introduction
2. Structure of “Mark I” Boiling Water Reactor
3. Available Core Cooling Systems  
in the Fukushima Accident after SBO
4. How the Reactor Cores Now ?

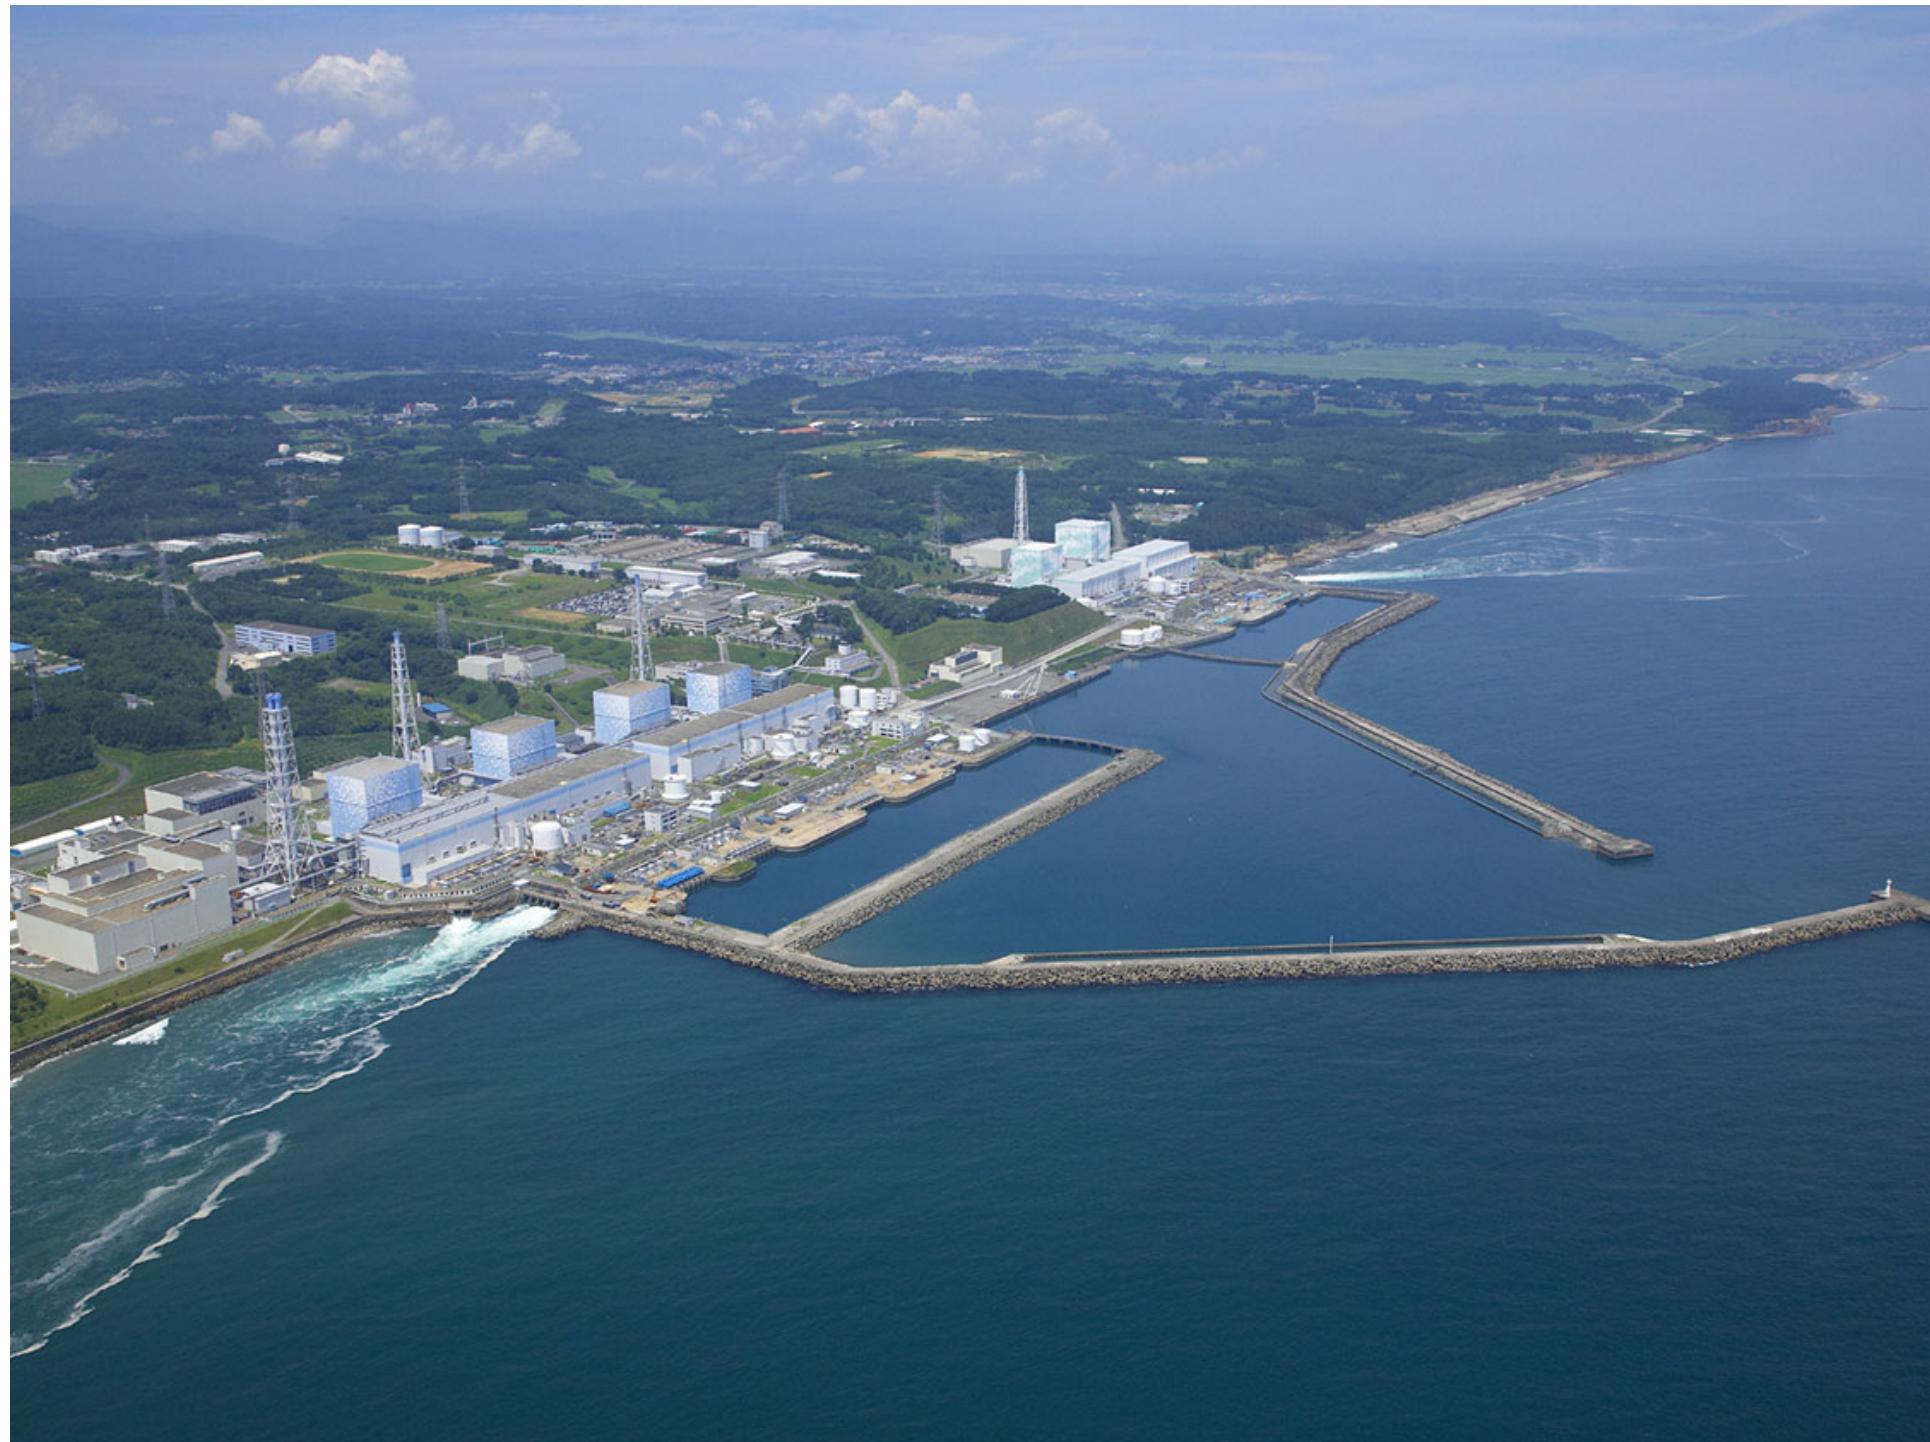
25m掘削  
原子炉を  
設置

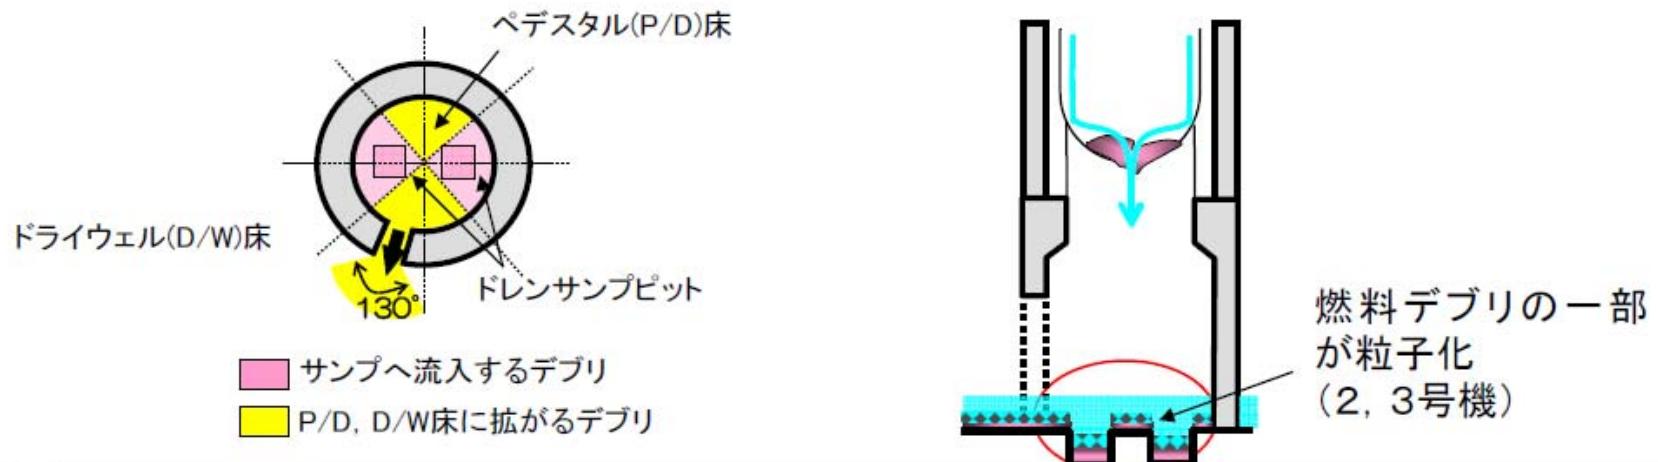
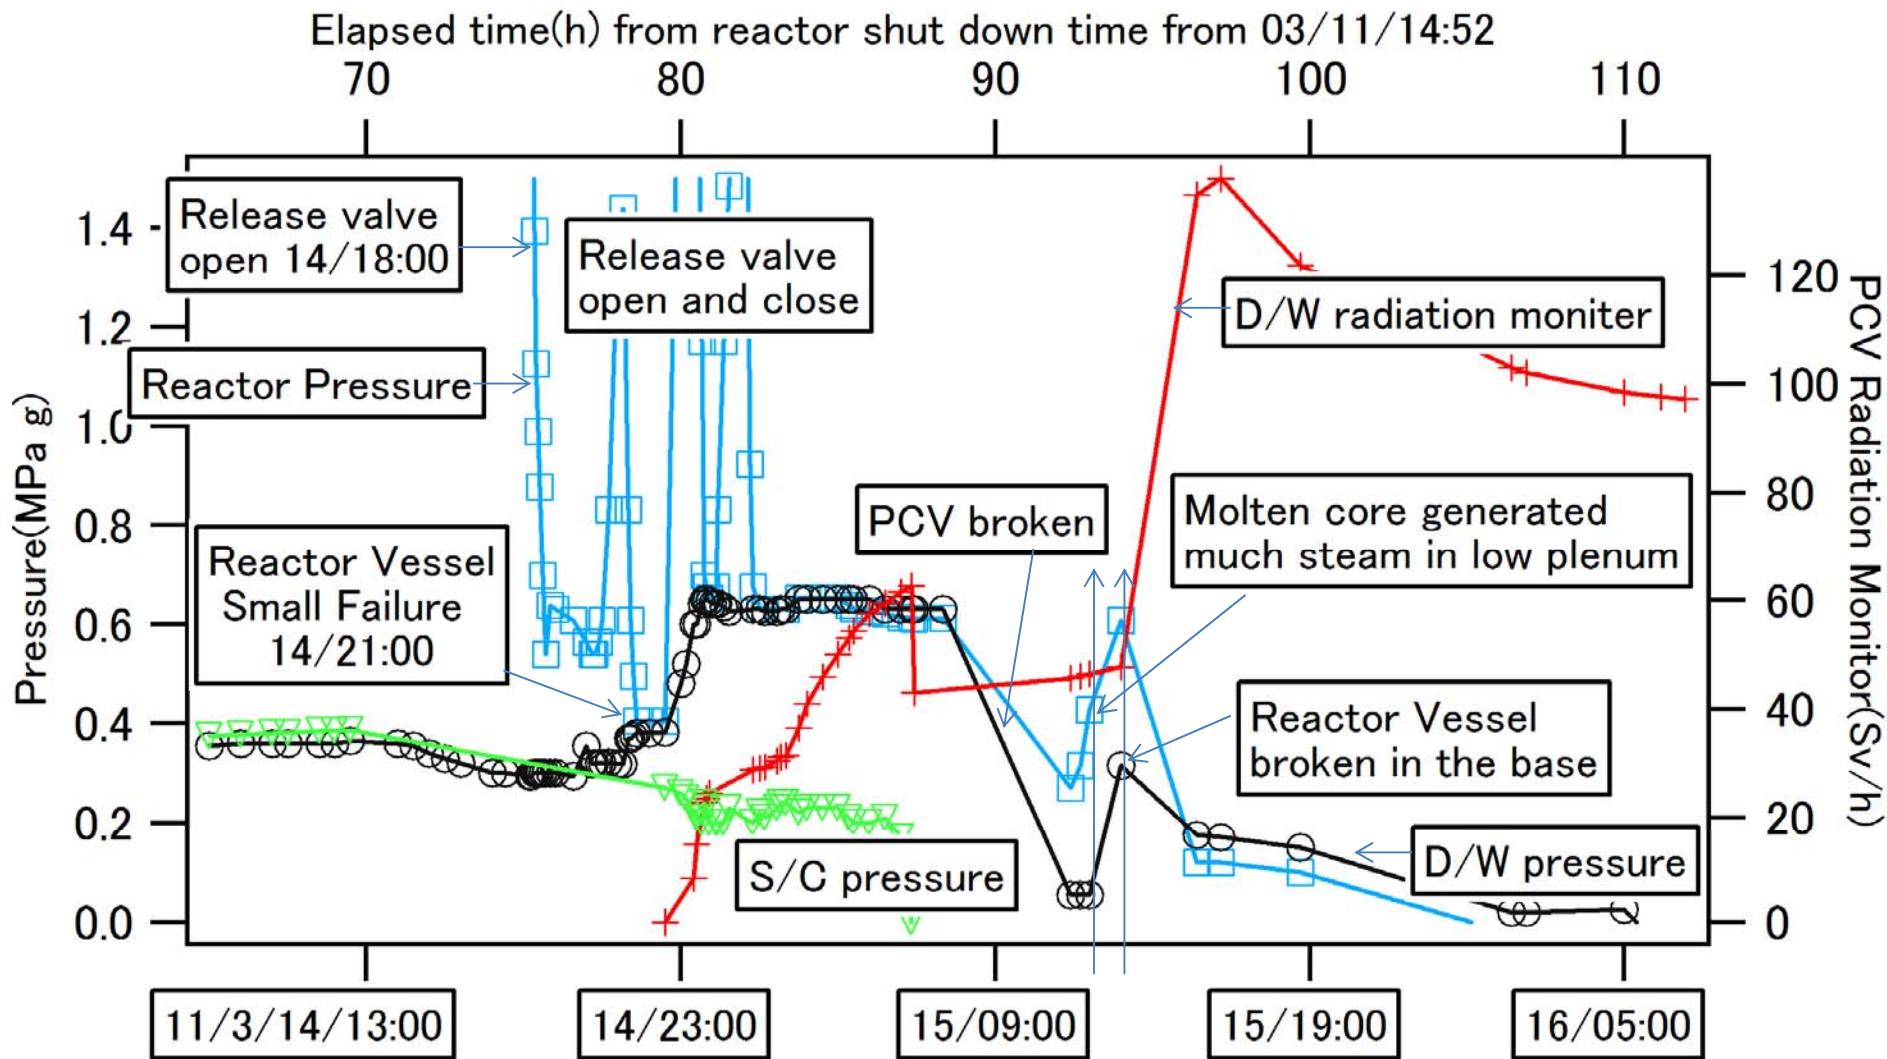
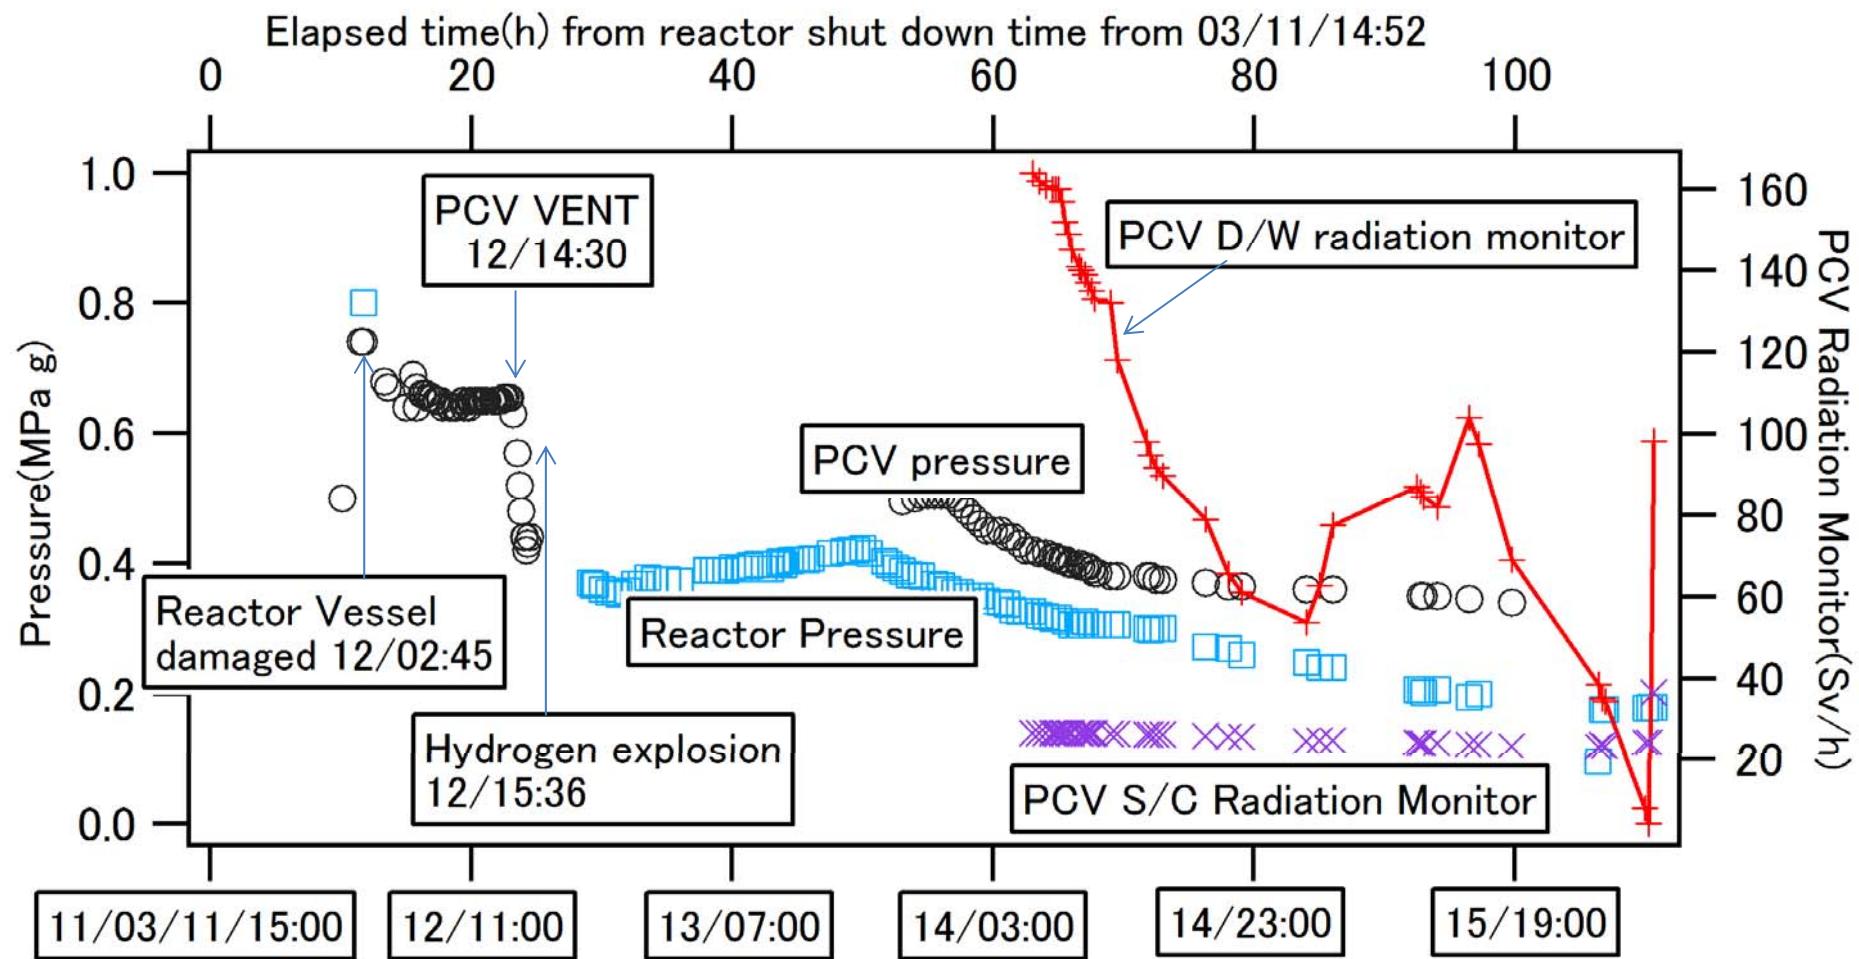
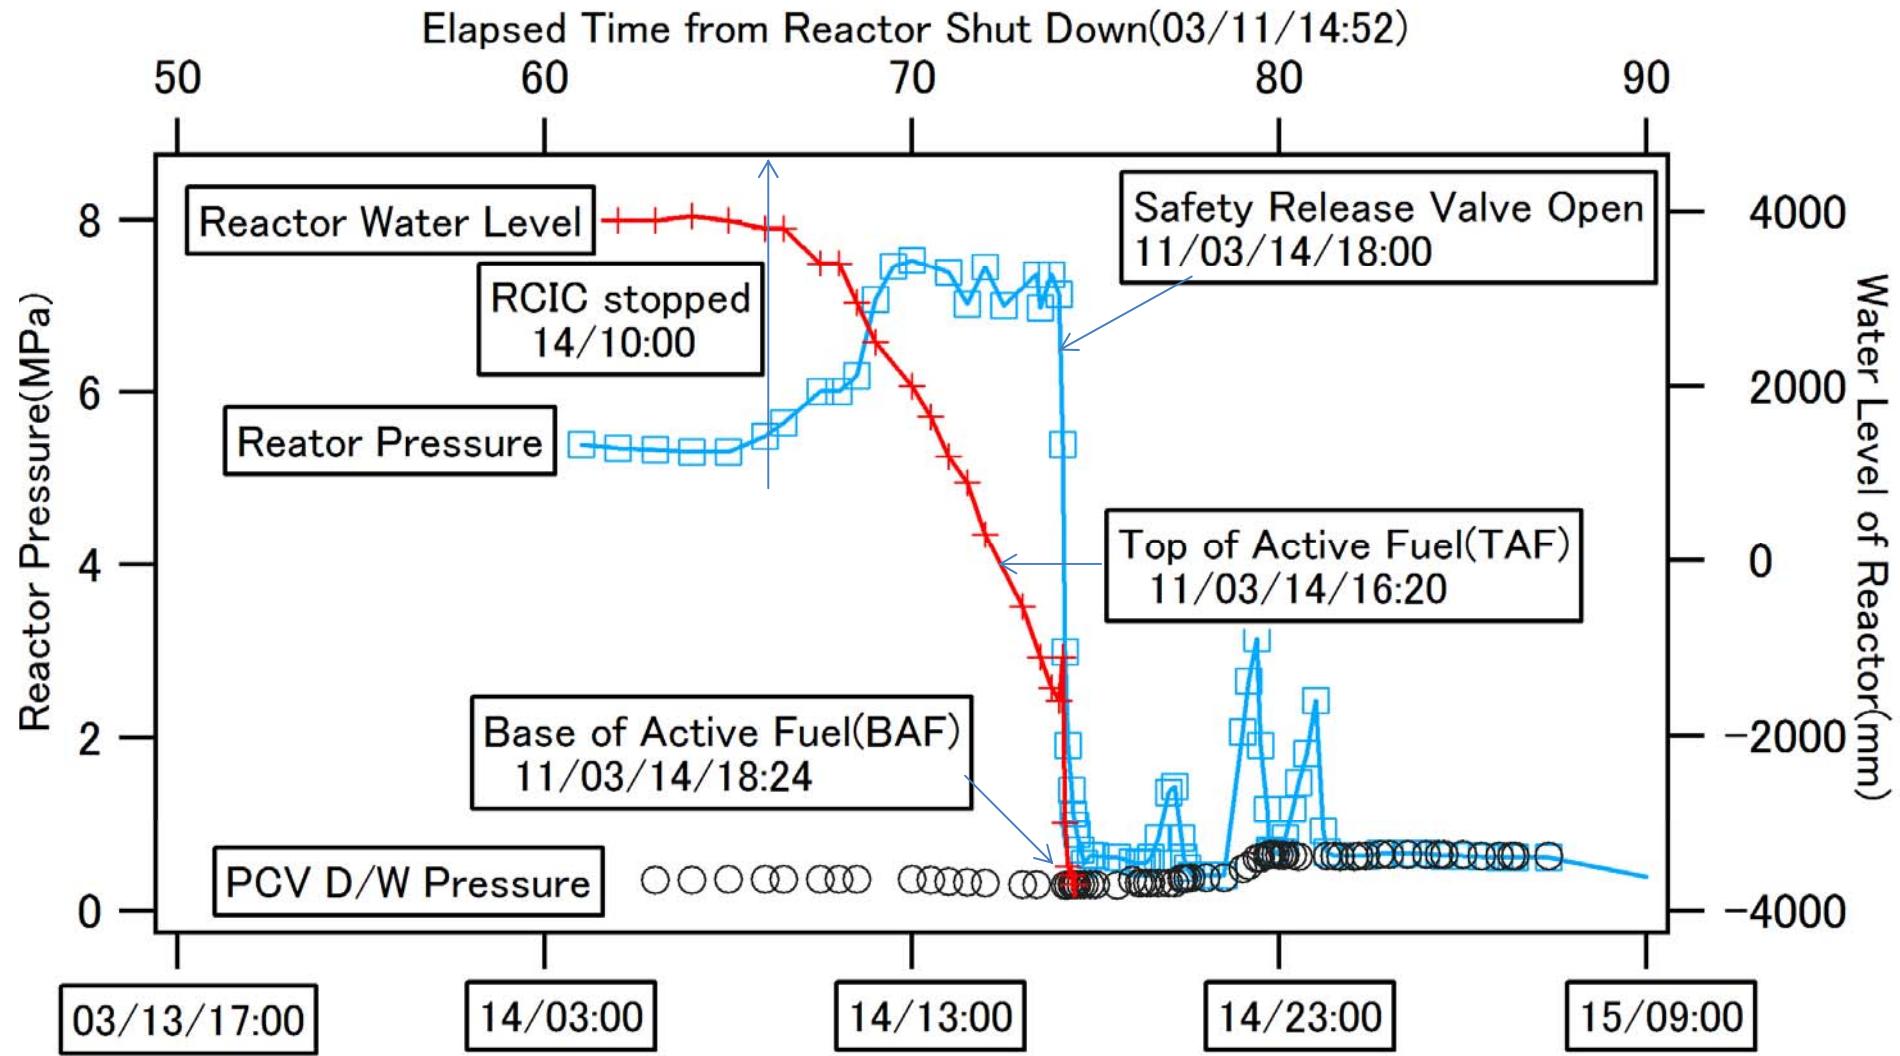
- 落下炉心割合はMAAP解析から得られた最大の値を保守的に仮定(1号機: 100%、2号機: 57%、3号機: 63%)
- 崩壊熱ソースはORIGEN2を使用。揮発性FPの放出による崩壊熱の減損(20%)を仮定
- 燃料デブリ落下時点までにPLRメカシールからのリーク水がペデスタル部に十分溜まっていた場合(2, 3号機)は燃料デブリが一部粒子化すると仮定  
※粒子化しなかった燃料デブリによる侵食を評価
- 燃料デブリはペデスタル床からスリットを通してドライウェル床まで流出。ペデスタル内にある2つ(機器／床)のドレンサンプへも燃料デブリが堆積すると仮定
