Interim Report on Radiation Survey in Iitate Village area conducted on March 28th and 29th

Iitate Village Area Radioactive Contamination Investigation Team

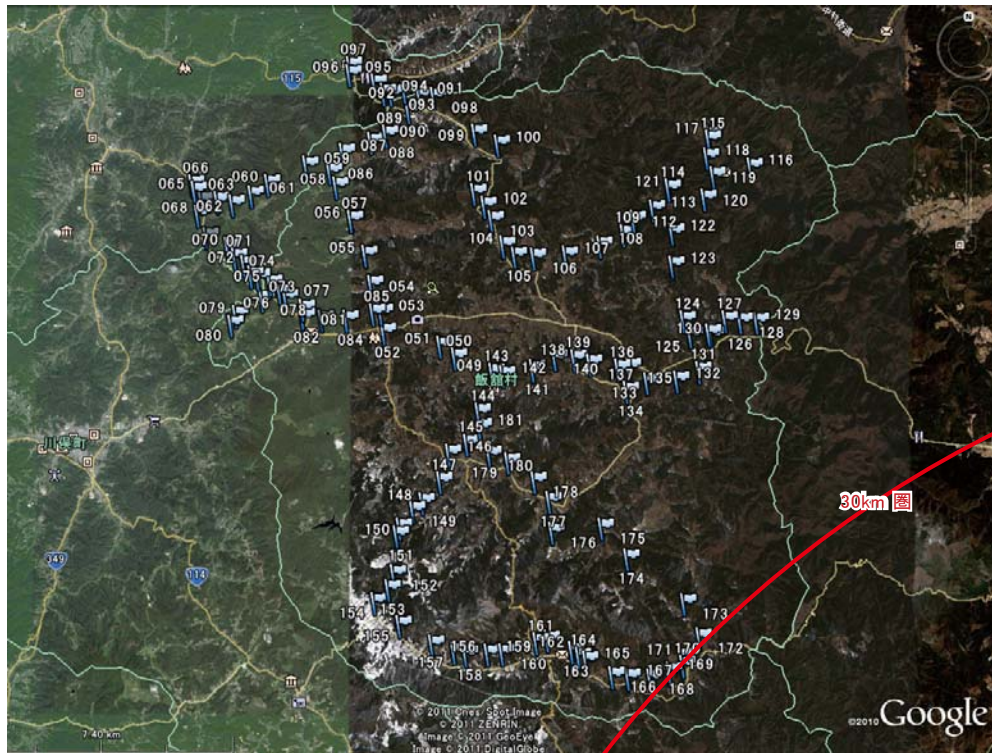
Figure 1. Dosimetry points

Figure 1 shows radiation dose measurement points recorded with GPS. Figure 2 shows contours of radiation dose based on measurement results.

The soil samples of 5cm deep were obtained at # 49, # 53, # 88, # 98, # 165 as shown in Figure 1. The soils were divided into 40g subsamples and with Ge semiconductor detector, gamma ray radionuclide analysis was conducted in the Radiation Laboratory, the Graduate School of Engineering, Hiroshima University, First an example of gamma ray spectrum measurement is shown in Figure 3.

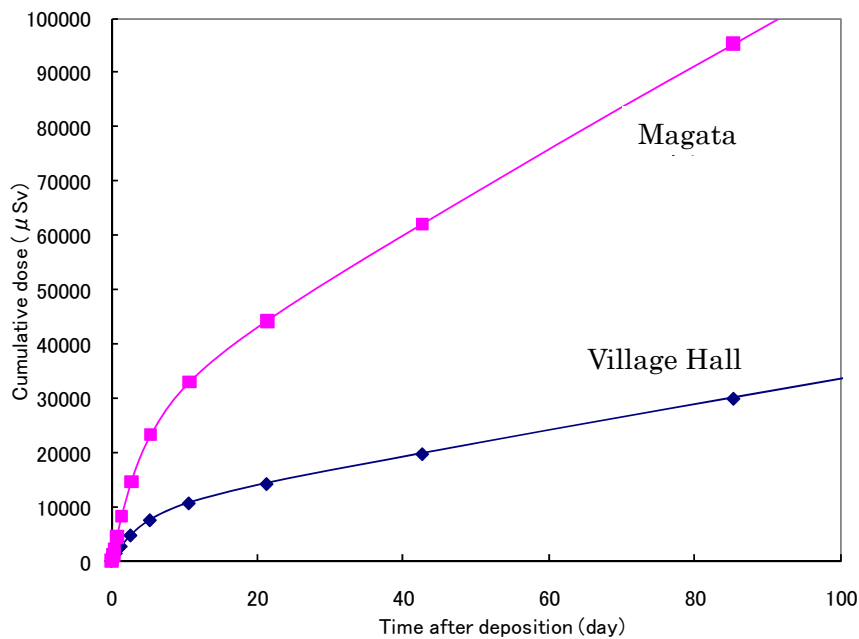
Figure 5. Cumulative Dose at litate Village Office and Magata (Microsievert)

For reference, using the soil contamination data from Table 1, radiation dose rate was calculated at Magata settlement where highest radiation dose rate was measured. This dose rate being approximately 200 micro-Sv per hour on March 15th, 2011 indicates the expected exposure of about 5 mSv per DAY. Figure 5 shows the increase in cumulative exposure in litate Village office and Magata settlement obtained by integrating the radiation dose rates shown in Figure 4.

Following from Figure 5, the estimated accumulative exposure to radiation over 90 days beginning from the March 15 low is 95mSv for Magata and 30mSv for the litate Village Hall. These figures apply to the soil of pasture land and are slightly reduced depending on where one is. For example, riding in a car results in 2/3 the exposure, being inside of a wooden framed house is 1/2, and being inside of a concrete building is 1/10.

According to the “Indoor Evacuation and Mandatory Evacuation Index” as described by the Nuclear Power Safety Committee’s “Measures to Prevent Disasters at Nuclear Power Plants”, given the amount of radioactive contamination and time of exposure, 10 to 50mSv requires that shelter be taken indoors, and levels above 50mSv require that shelter be taken in a concrete building or to evacuate. There is no doubt that radioactive contamination in litate Village is a critical issue.

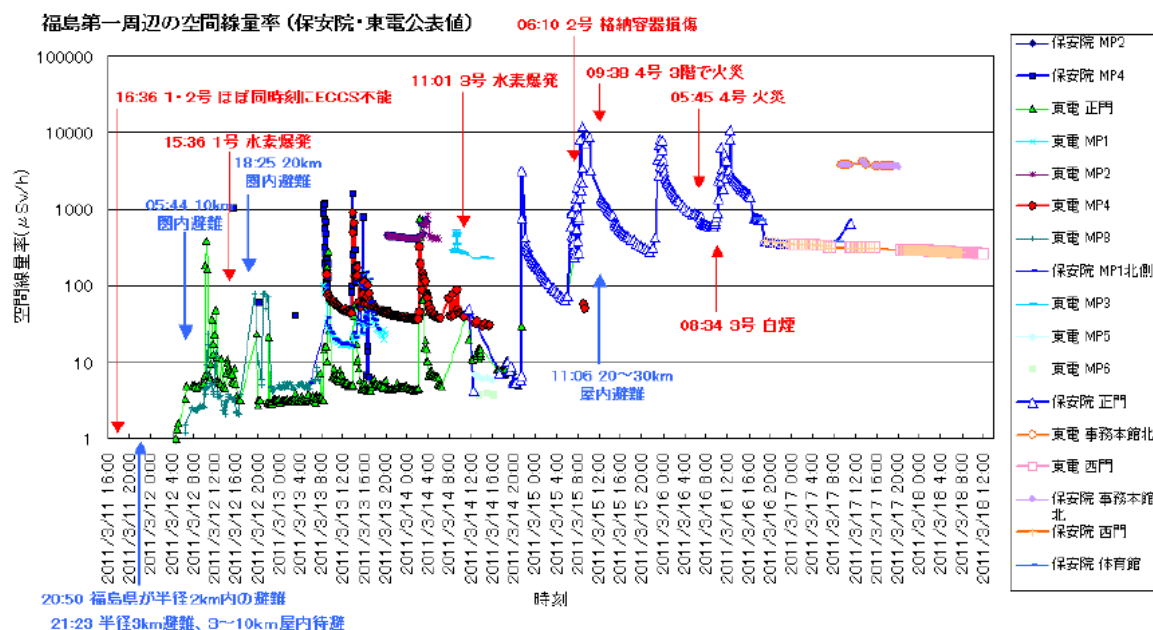
①放射線量の変化と事故の経過(～3/18 12:00)

According to the above figure, on the morning of March 15 there was a large emission of radioactivity due to the destruction of the second reactor's containment vessel and the fire in the fourth reactor's spent fuel pool. It can be considered that this radioactive pollution traveled northwest and left a trail of highly radioactive contamination. Due to the amount of radioactive iodine found, it is believed that the destruction of the second reactor's containment vessel at 6:10 on March 15 emitted a large quantity of radiation towards the northwest.

According to the data of attachment 1, the maximum radiation dose rate of 44.7 μ Sv/h occurred at 18:20 on March 15th. The right chart is the record of meteorological condition in Iitate village of March 15.

It is considered that the destruction of the second reactor's containment vessel at 6:10 on March 15 induced a nuclear cloud which took 12 hours to reach and hover over the area of Iitate Village. (On the chart to the right, "///" signifies that no data is available.)

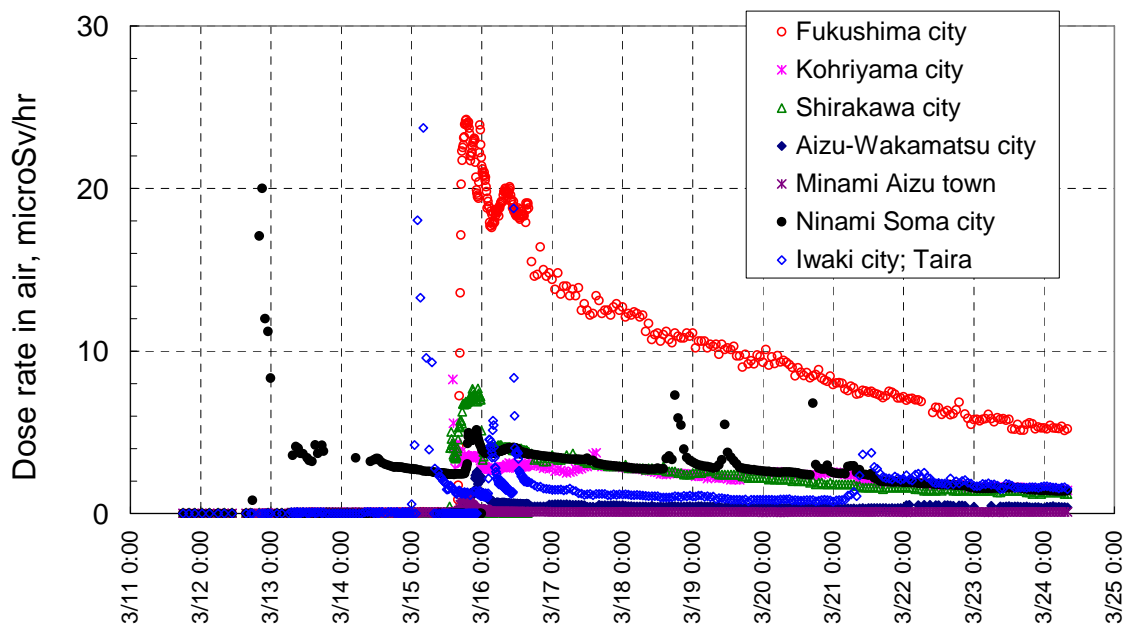
Change of radiation dose rate (1): March 11 -

One of my friends sent me e-mail with radiation dose data measured at various places in Fukushima prefecture. He got these data from the Internet released from the prefecture headquarter for the disaster. The followings indicate temporal change of radiation dose rate in the environment. Locations are in the next maps.

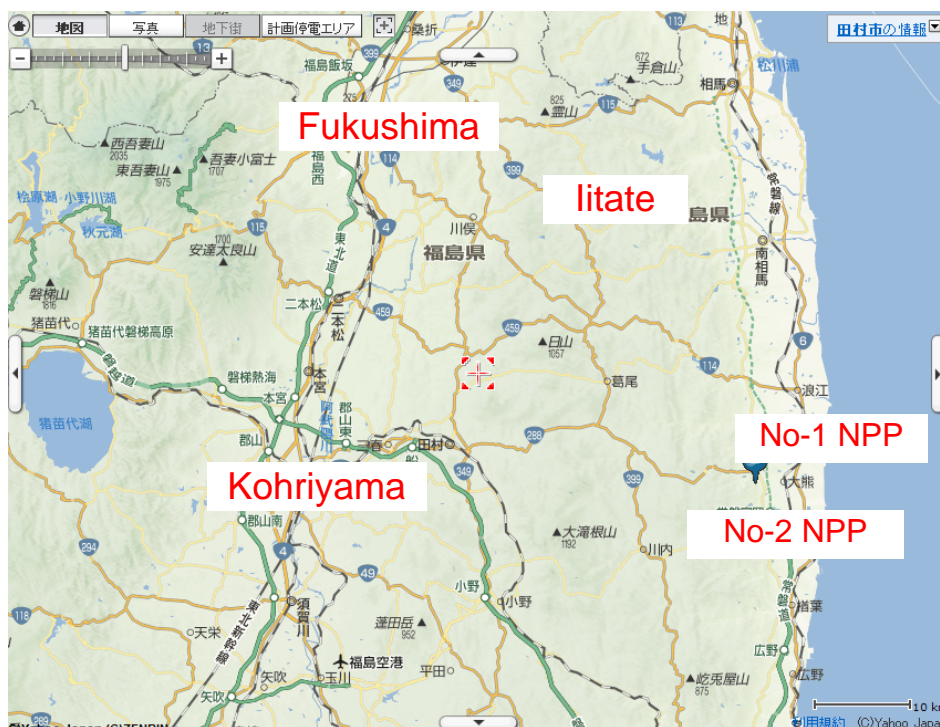
Appendix-1

Location of monitoring points and Fukushima No-1 NPP
